CONNECTICUT RIVER BASIN
HANOVER, NEW HAMPSHIRE

LOWER RESERVOIR DAM

NH 00048

PHASE I INSPECTION REPORT NATIONAL DAM INSPECTION PROGRAM

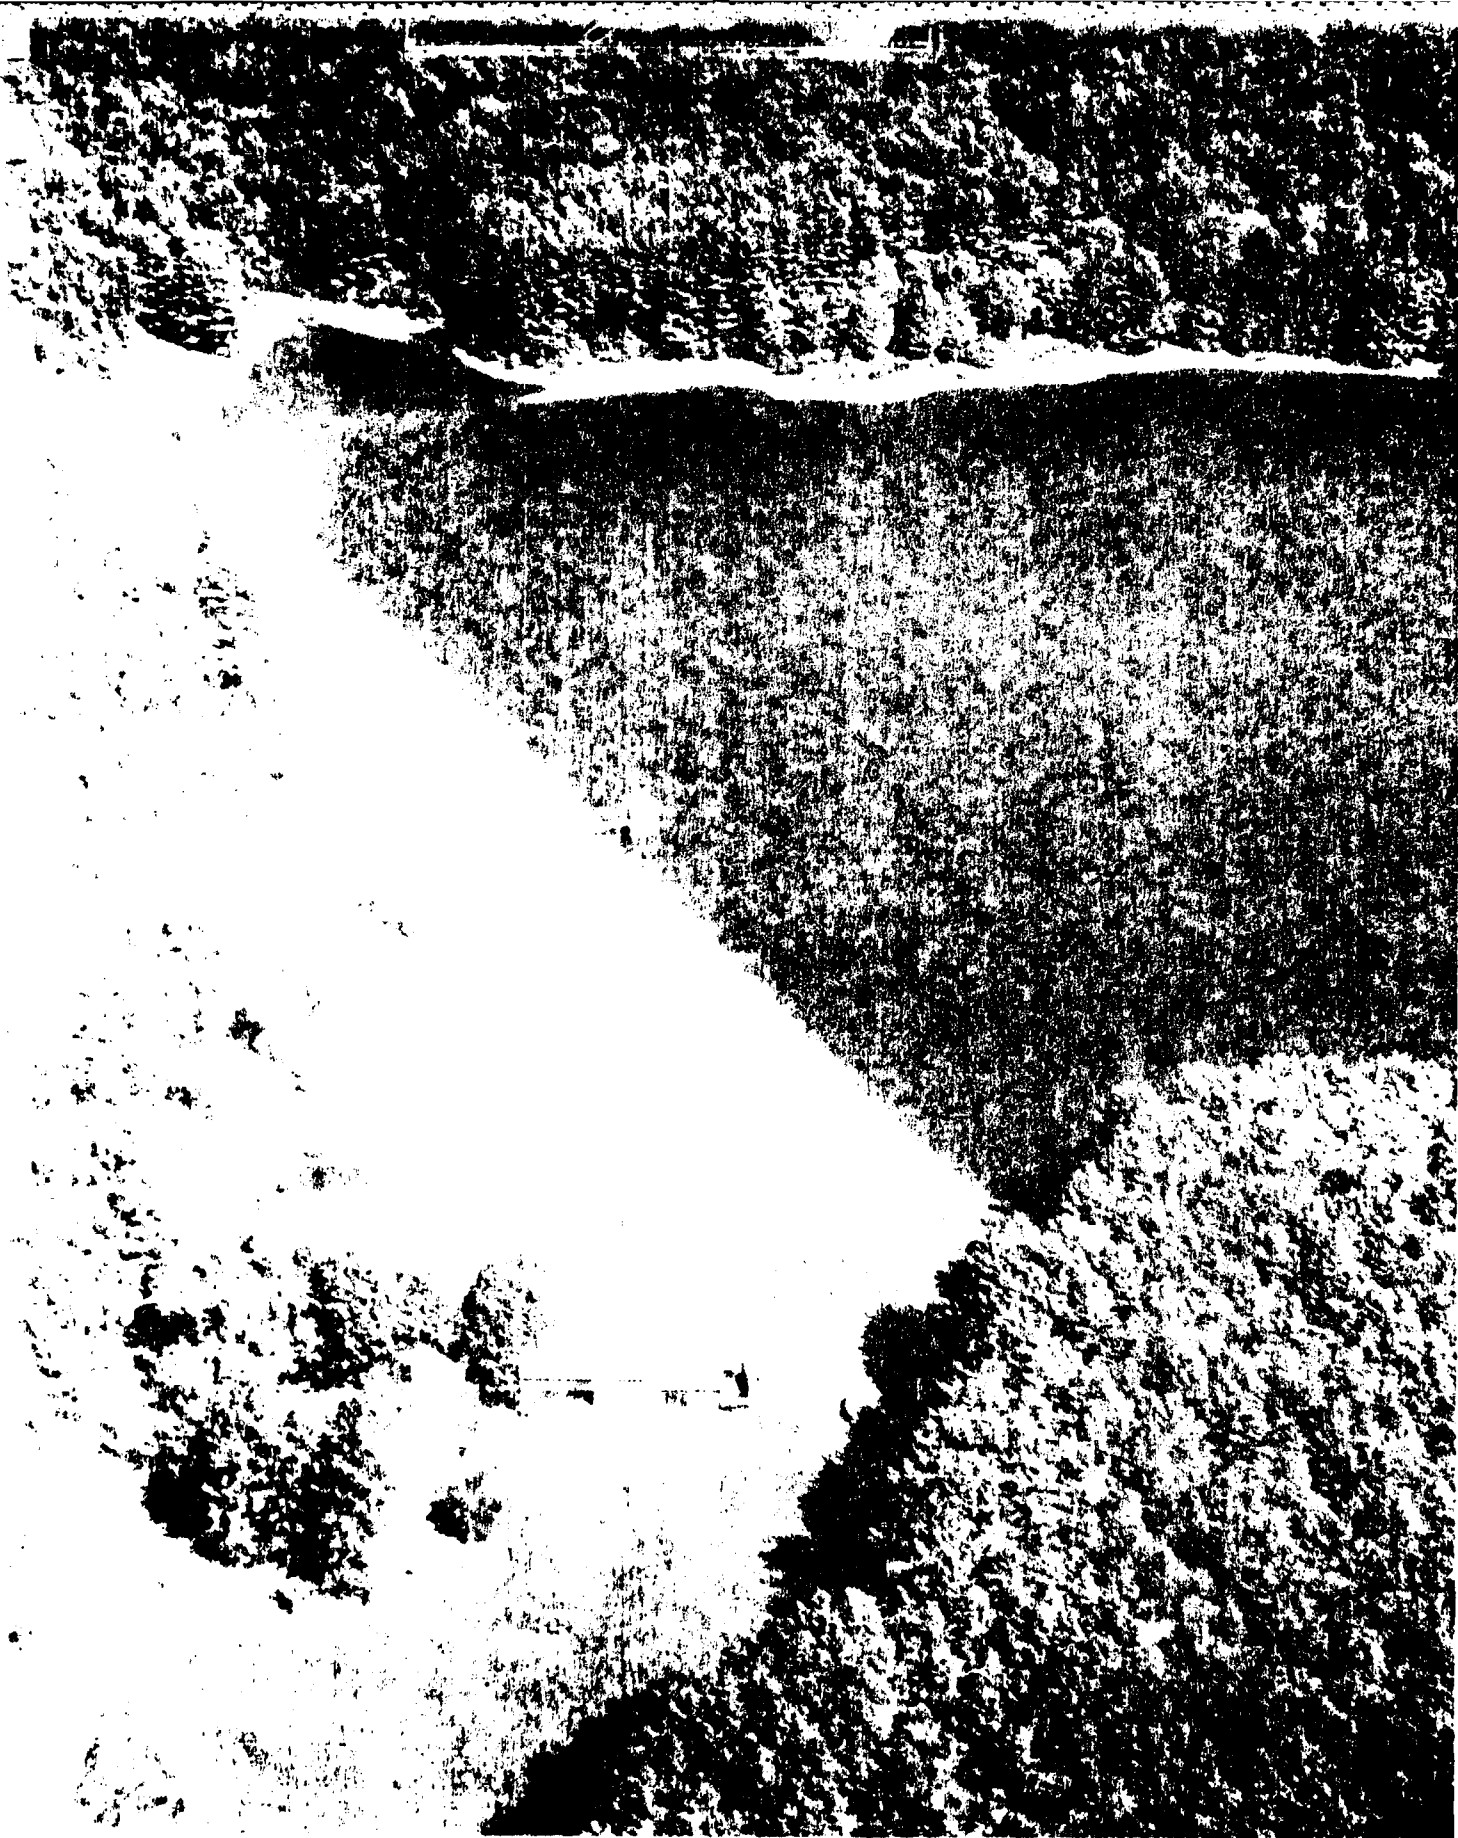
Lower Reservoir Dam - Overview from above left abutment.

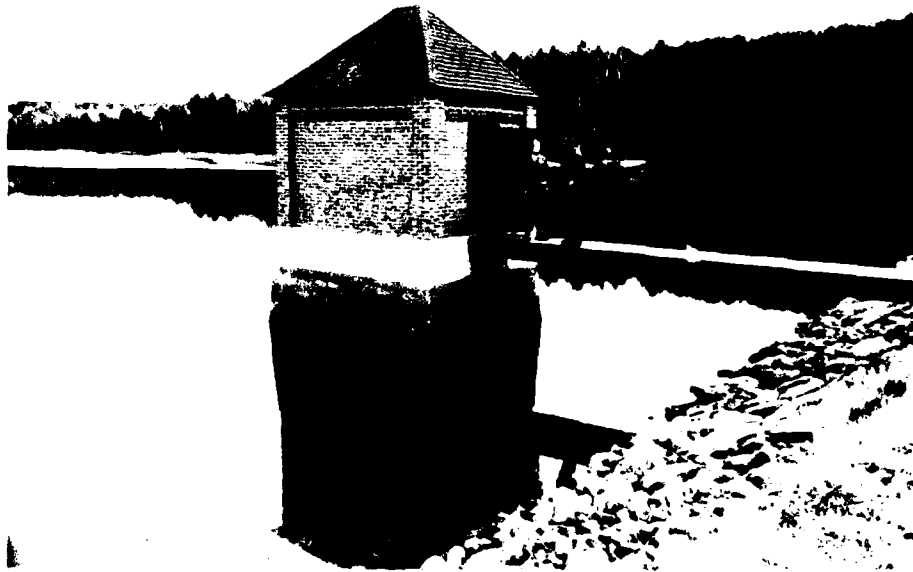
PHOTO NO. 6 - Gatehouse as seen from the crest of the dam.

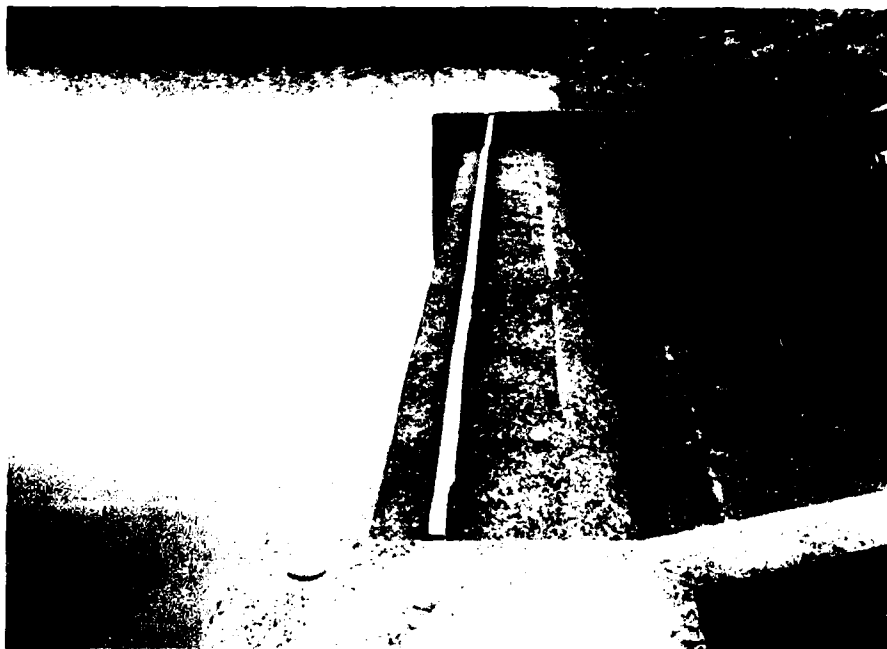
The flashboards on the spillway crest were in good condition. However, there is no means of removing the flashboards during high water without exposing personnel to hazardous conditions.

PHOTO NO. 7 - Weir crest and flashboards of the spillway.

(c) Devise a means to allow removal of the flashboards during high water so that personnel will not be exposed to hazardous conditions during the removal operation.

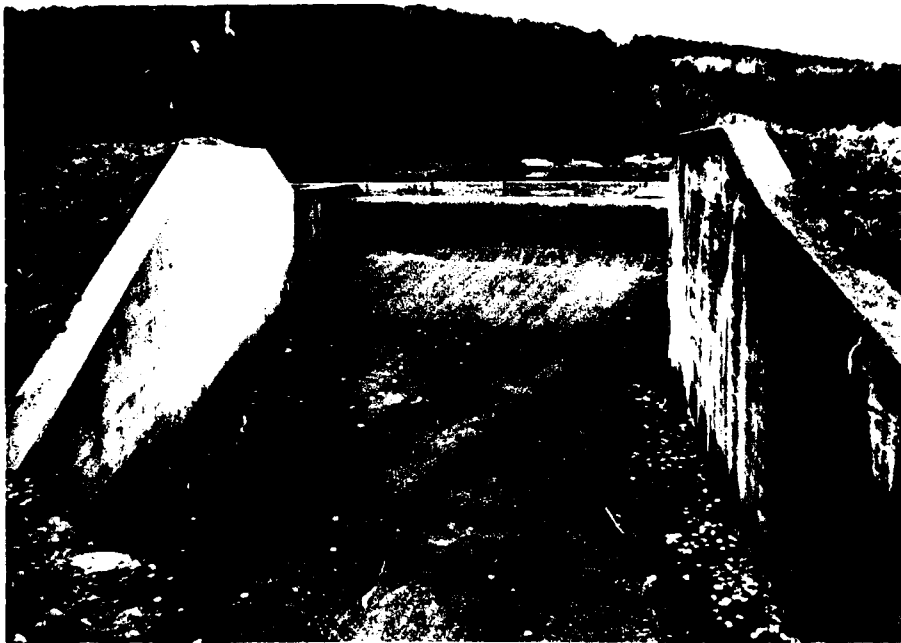
PHOTO NO. 8 - View of the downstream side of the spillway weir crest.

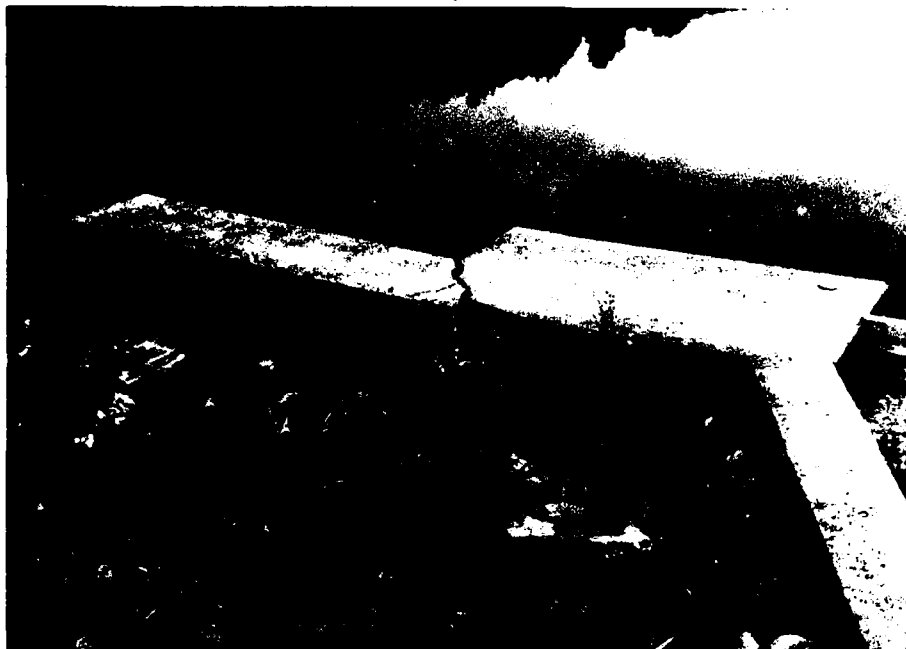
The right wingwall at the approach to the spillway is cracked through the entire wall thickness and reinforcement is visible as shown in Photo No. 12.

(e) Reinforcing steel has been exposed through a crack in the upstream right wingwall of the spillway.

PHOTO NO. 12 - Upstream right side of the spillway training wall. Note large crack.

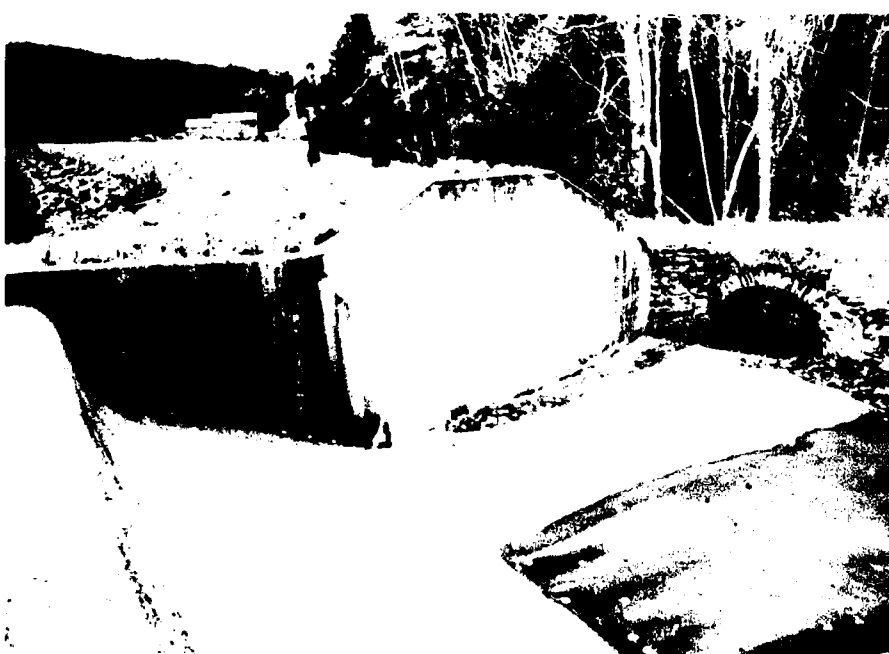
PHOTO NO. 13 - Masonry bridge at downstream end of spillway section.

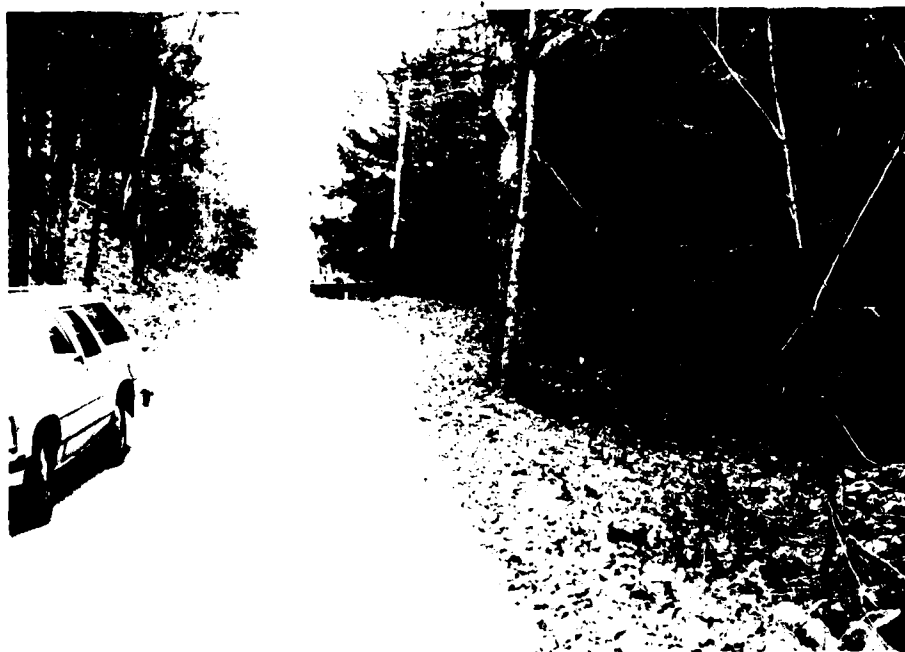
PHOTO NO. 20 - Roadway and outlet channel about 500 feet downstream of dam. The channel is in low area to the right of the photo.

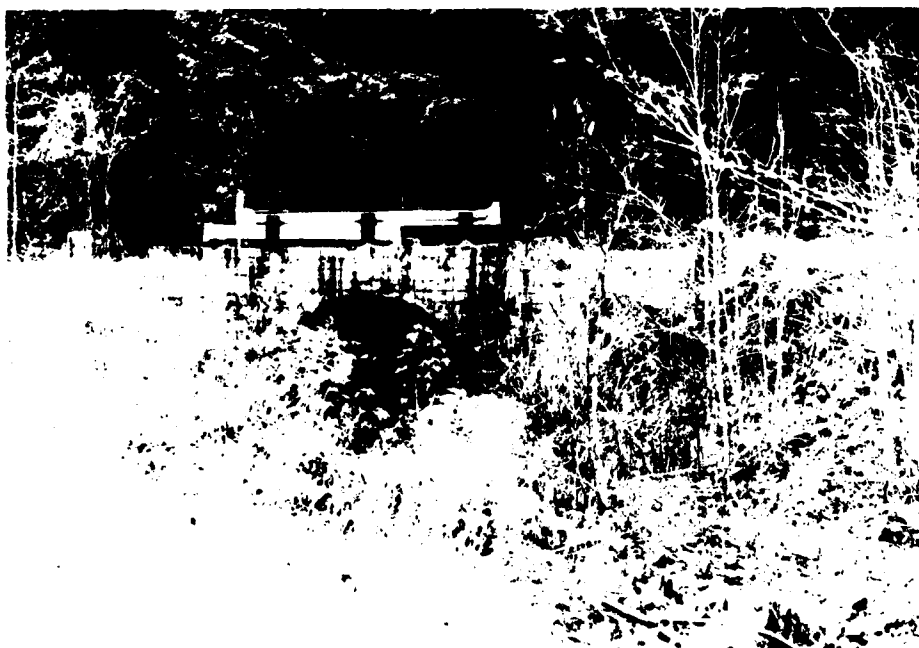
PHOTO NO. 21 - Reservoir road bridge over Camp Brook located about 3000 feet downstream of the dam.
